Lake Lemon T by 2000 Feasibility Study

William W. Jones
Louise Clemency

July 1992

LAKE LEMON ENHANCEMENT STUDY

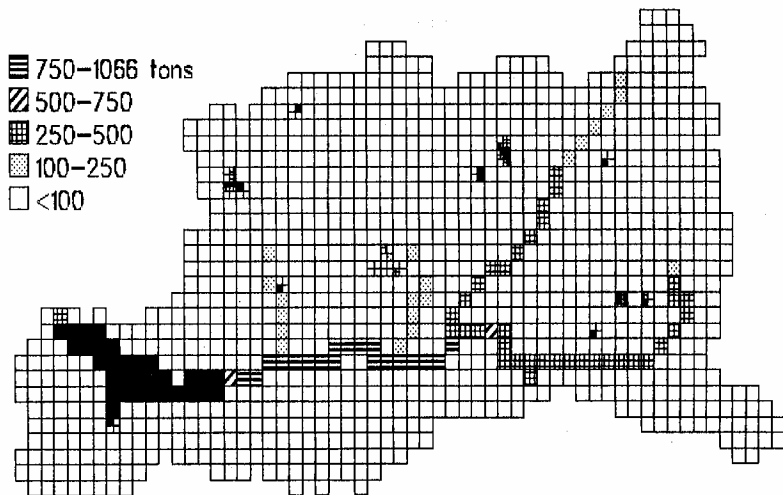
Figure 4-7. Sediment yields for the modeled storm event.
